AUSTRALIAN NATIONAL
MARITIME MUSEUM

Archaeological identification of the shipwreck site RI 2394 in Newport Harbor, Rhode Island, USA

Preliminary report

24 January 2022 [Amended 11 February 2022]

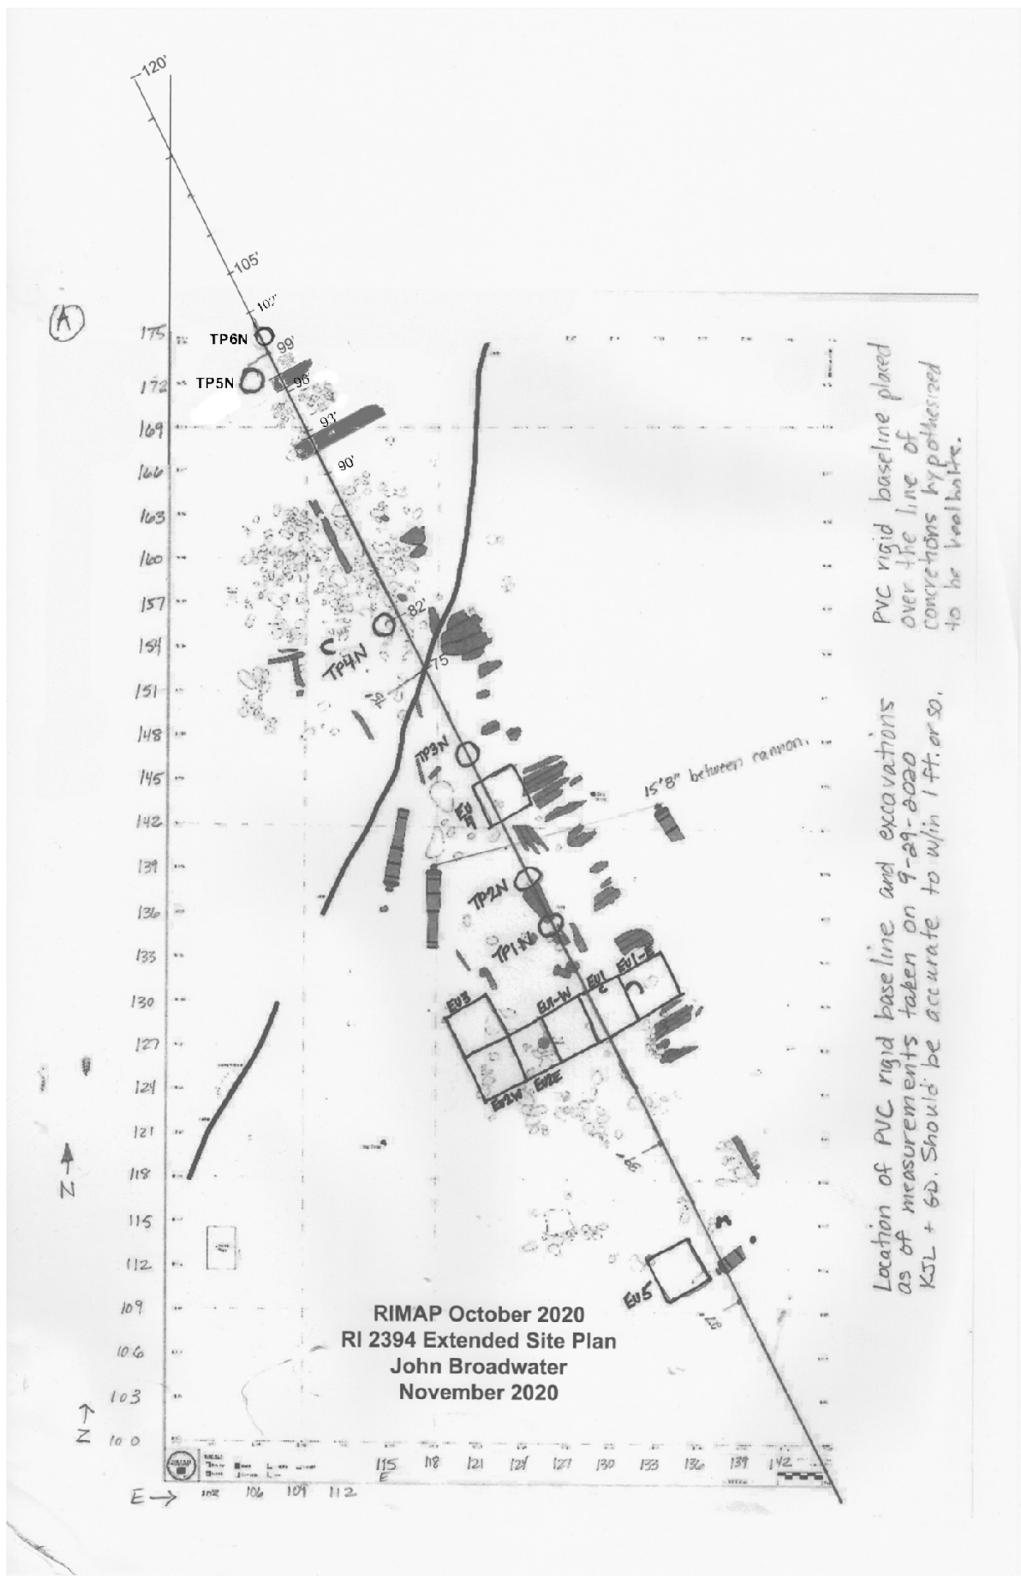
Fieldwork conducted during September and October 2020 revealed a significant number of large- and medium-sized ballast stones, numerous iron concretions, and a few small finds. Figure 10 and Figure 11 show the areas on the site where the expedition team focused most of its efforts.

Figure 10. RI 2394 Site Map Showing October 2020 work area (RIMAP site map, with additions by John D. Broadwater).

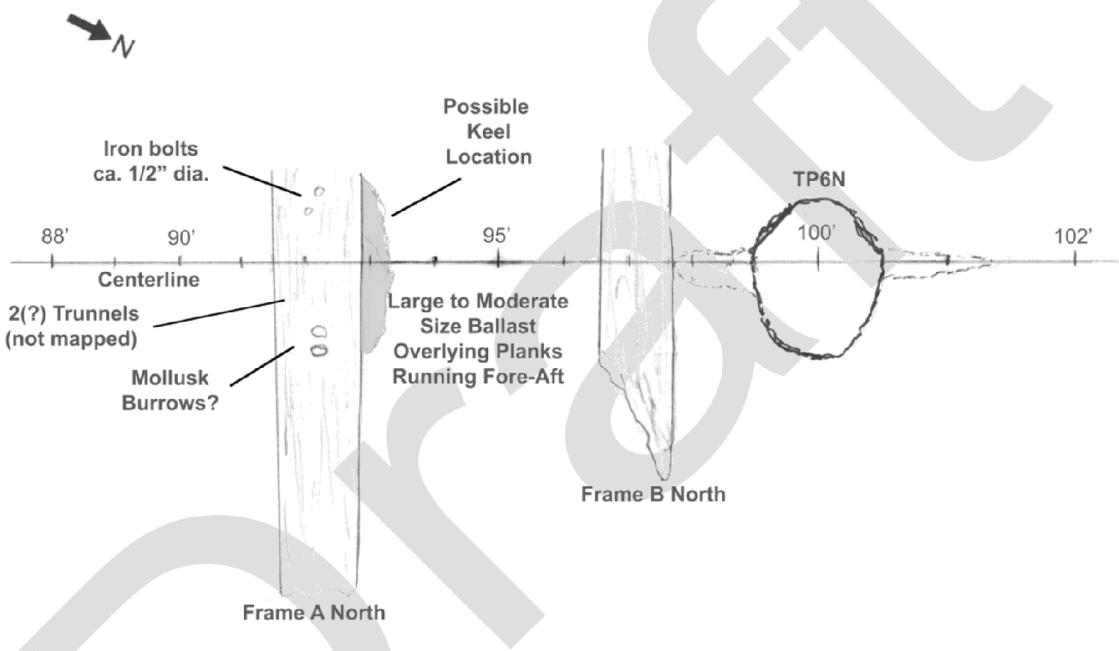
Figure 11. RI 2394 area of concentration, October 2020 (John D. Broadwater).

Figure 11 shows the two athwartship frames relative to TP6N. The upper sided surface of Frame A North features two large holes. These were located just east of the centreline and initially thought to be empty keel bolt holes. However, closer examination revealed the holes are not quite circular, do not contain adhering ferrous concretion, and were likely made by marine molluscs. To the west of the centreline, the upper sided surface of the same timber features remnants of what appear to be two small (approximately $\frac{1}{2}$ -inch, or 1.3-centimetre, diameter) iron bolts. These fasteners are too small to be keel bolts, and were instead likely used to affix hull or ceiling planking in conjunction with at least two treenails found protruding from the frame's lower sided face. The treenails were cut flush with the timber's upper sided face and may have been wedged. Spacing between the frames is significantly greater than that observed elsewhere on RI 2394 and suggests additional intermediate frames are missing. This in turn provides additional evidence of hull deterioration at the site's northern end. Because the team could not locate the keel in TP6N, a small exploratory test pit was excavated along the northern moulded face of Frame A North.

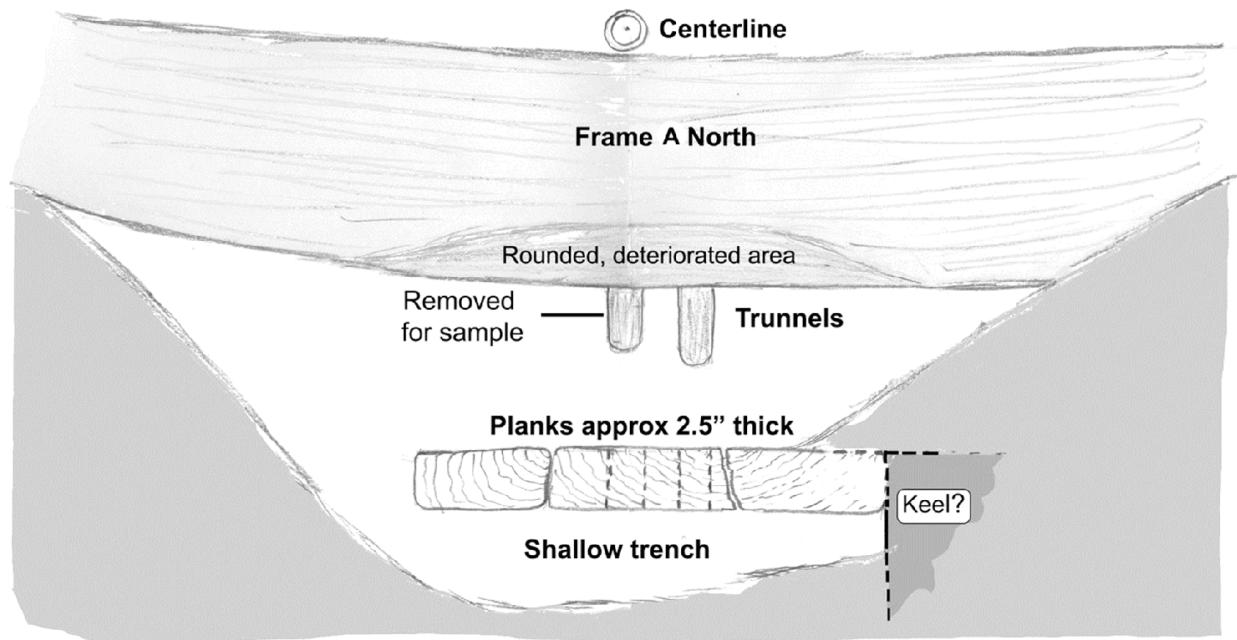
12 is a sectional sketch of TP6N that is roughly to scale. It reveals the hull planking is separated from the frame by approximately 5 inches (12.7 centimetres) and has exposed

two treenails that protrude from the frame's lower sided face. Because it was assumed the site's centreline baseline was aligned with the keel, the team's initial interpretation was that the floor was attached to the keel exclusively with treenails. However, this conclusion seems unlikely, given a floor timber – even if installed as an emergency replacement – would have been affixed to the keel with more robust metal fasteners.

Figure 12. Cross-section through TP6N southern extension, at Frame A North, facing south, showing outer planking pulled free from Frame B North. Also shown is the possible keel, located on the last dive. Scale approximate. (John D. Broadwater).

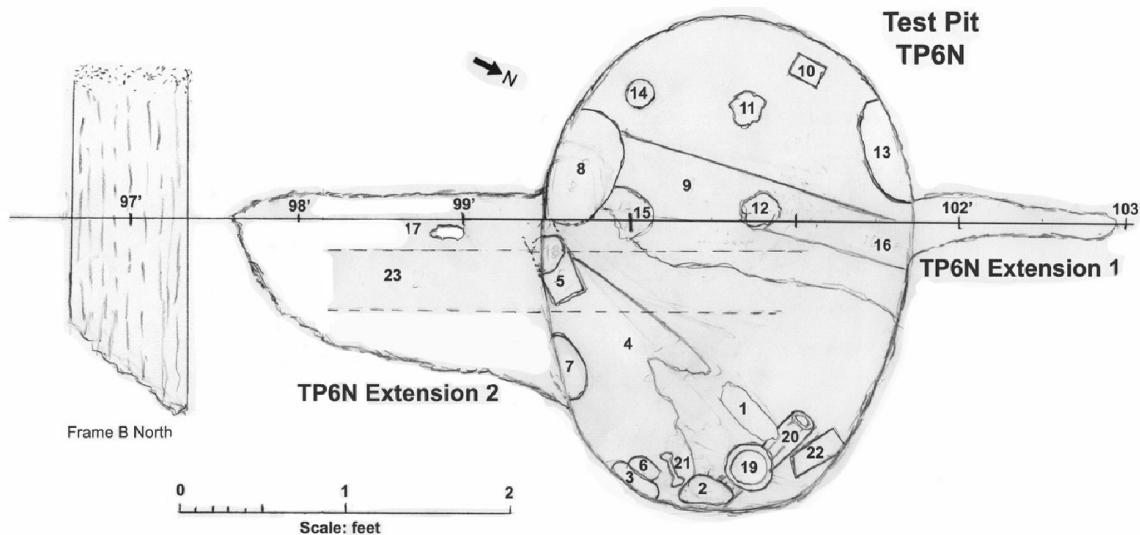
One curious feature found in TP6N is a very wide plank at the test pit's western extremity through which a 2-inch (5.1-centimetre) hole has been drilled (Object No. 14 in Figure 13). The hole does not retain staining or concretion residue that might be associated with a fastener that has since disappeared. In addition, the plank does not appear to be aligned with the run of the keel. Given its unusual size, the presence of the hole, and its proximity to the suspected location of the keel, the plank could be a limber board. Alternatively, it may be a hull plank and the hole a scuttling hole produced with a drill.

Figure 13. RI 2394: Details of test pit TP6N (John D. Broadwater).

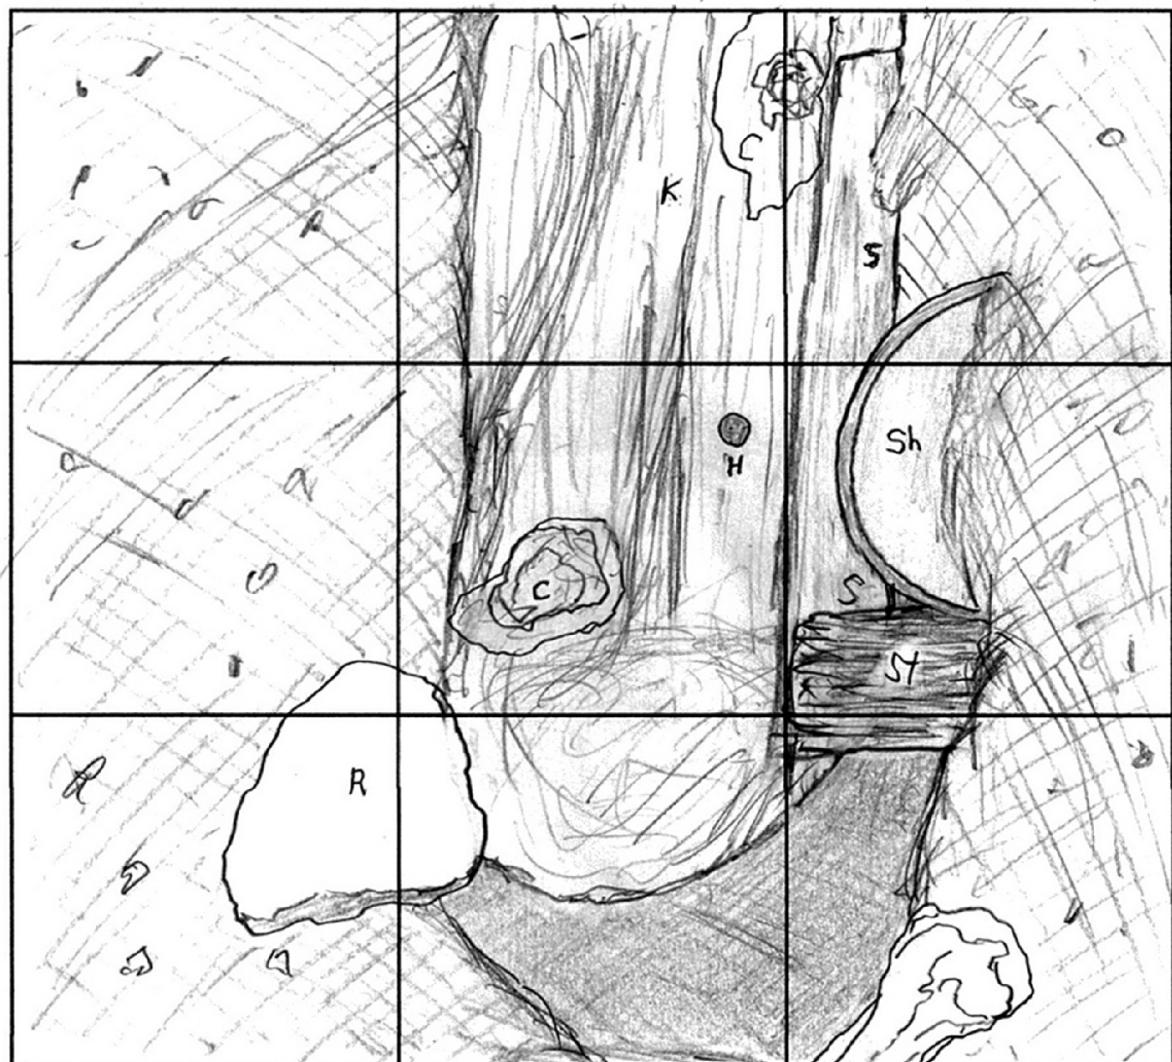
Fortunately, the keel's southern end was largely preserved and retained most of the scarph that connected it to the vessel's stem. Positive identification of the keel-stem scarph confirmed that RI 2394's bow faces south (see Figure 14 and Figure 15). The stem was absent, save for a small remnant timber fragment found lying within the scarph.

Figure 14. South end of keel, showing stem-keel scarph in plan view. Note that north is up (John D. Broadwater).

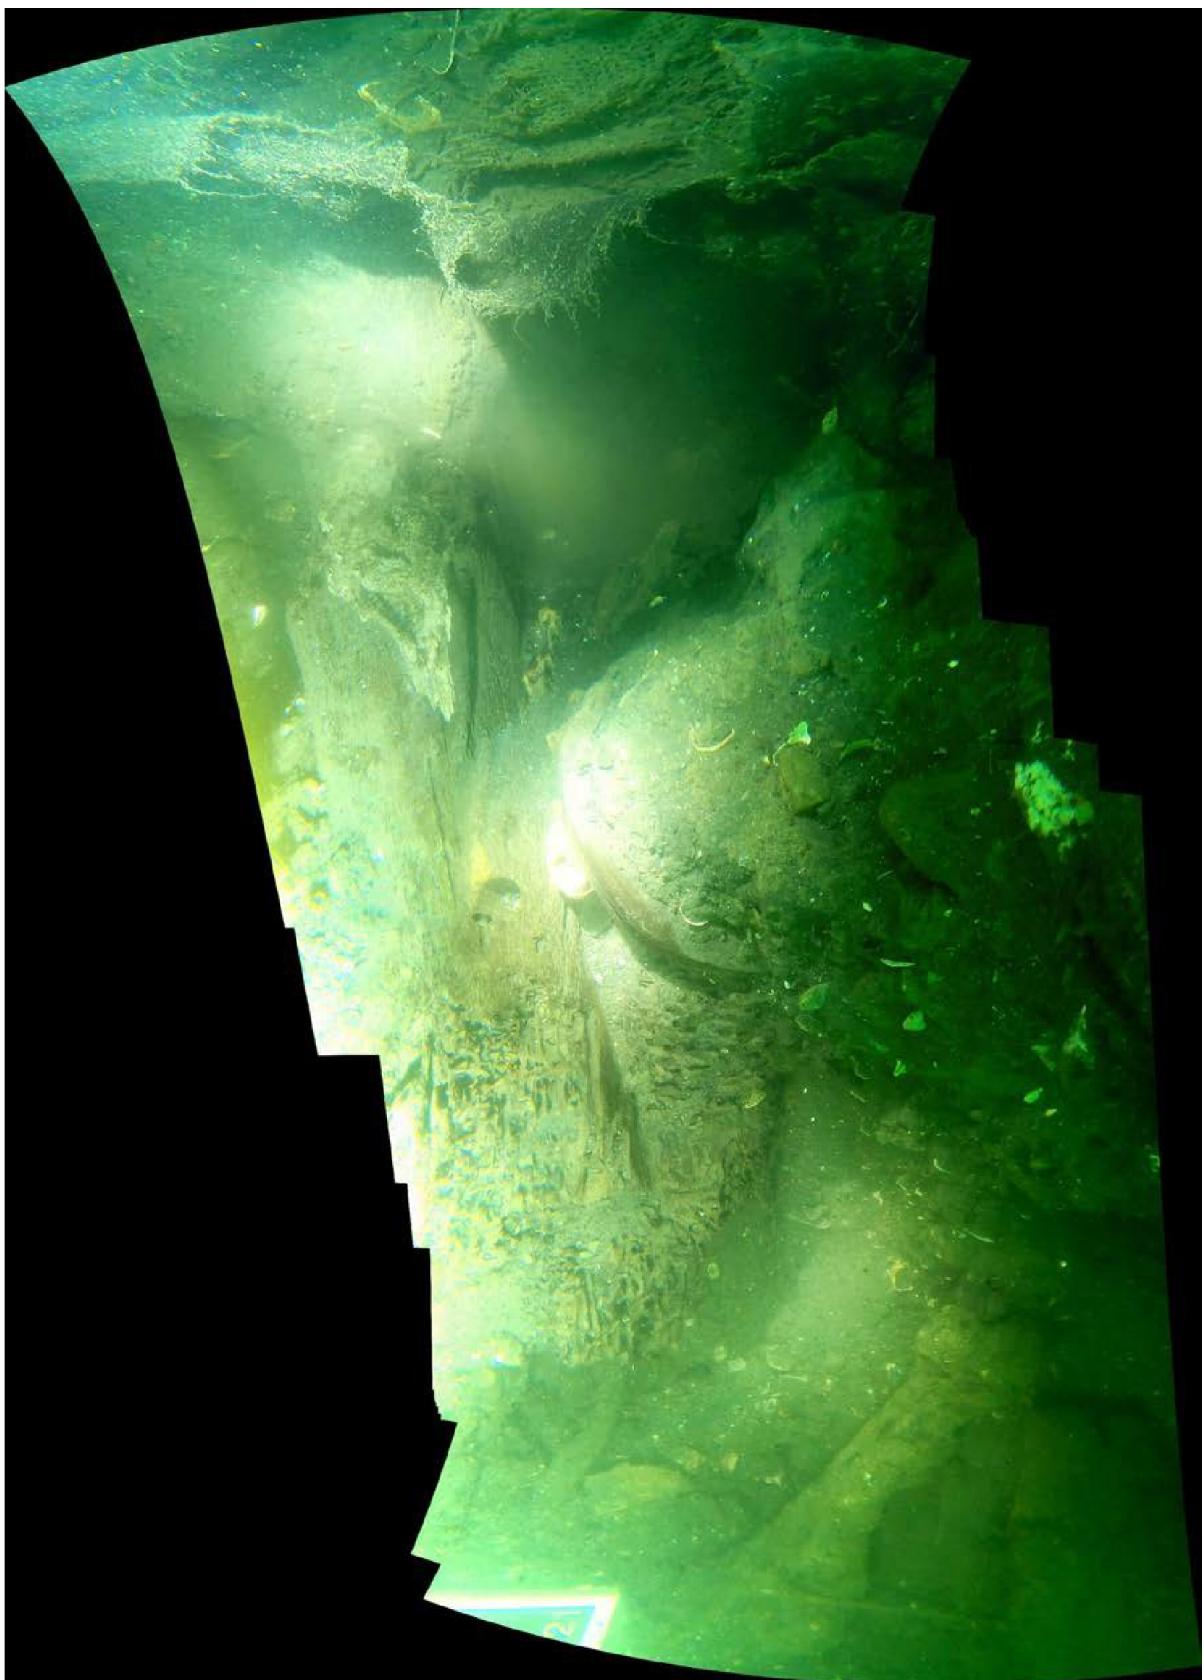
Figure 15. Photomosaic of keel's southern terminus, showing scarph for the stem (beneath wooden sheave at image centre). Note that north is up (John D. Broadwater and Joshua Daniel).

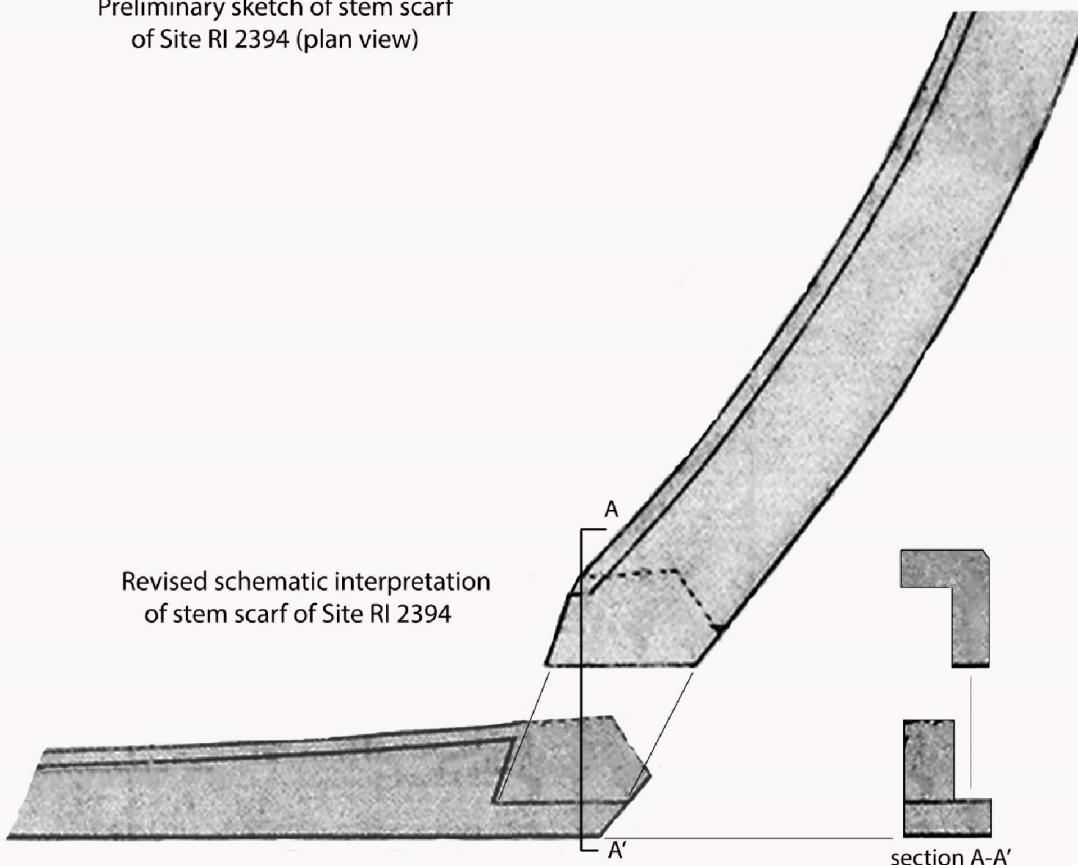
Figure 16. Reconstruction of RI 2394's stem scarf (John D. Broadwater)

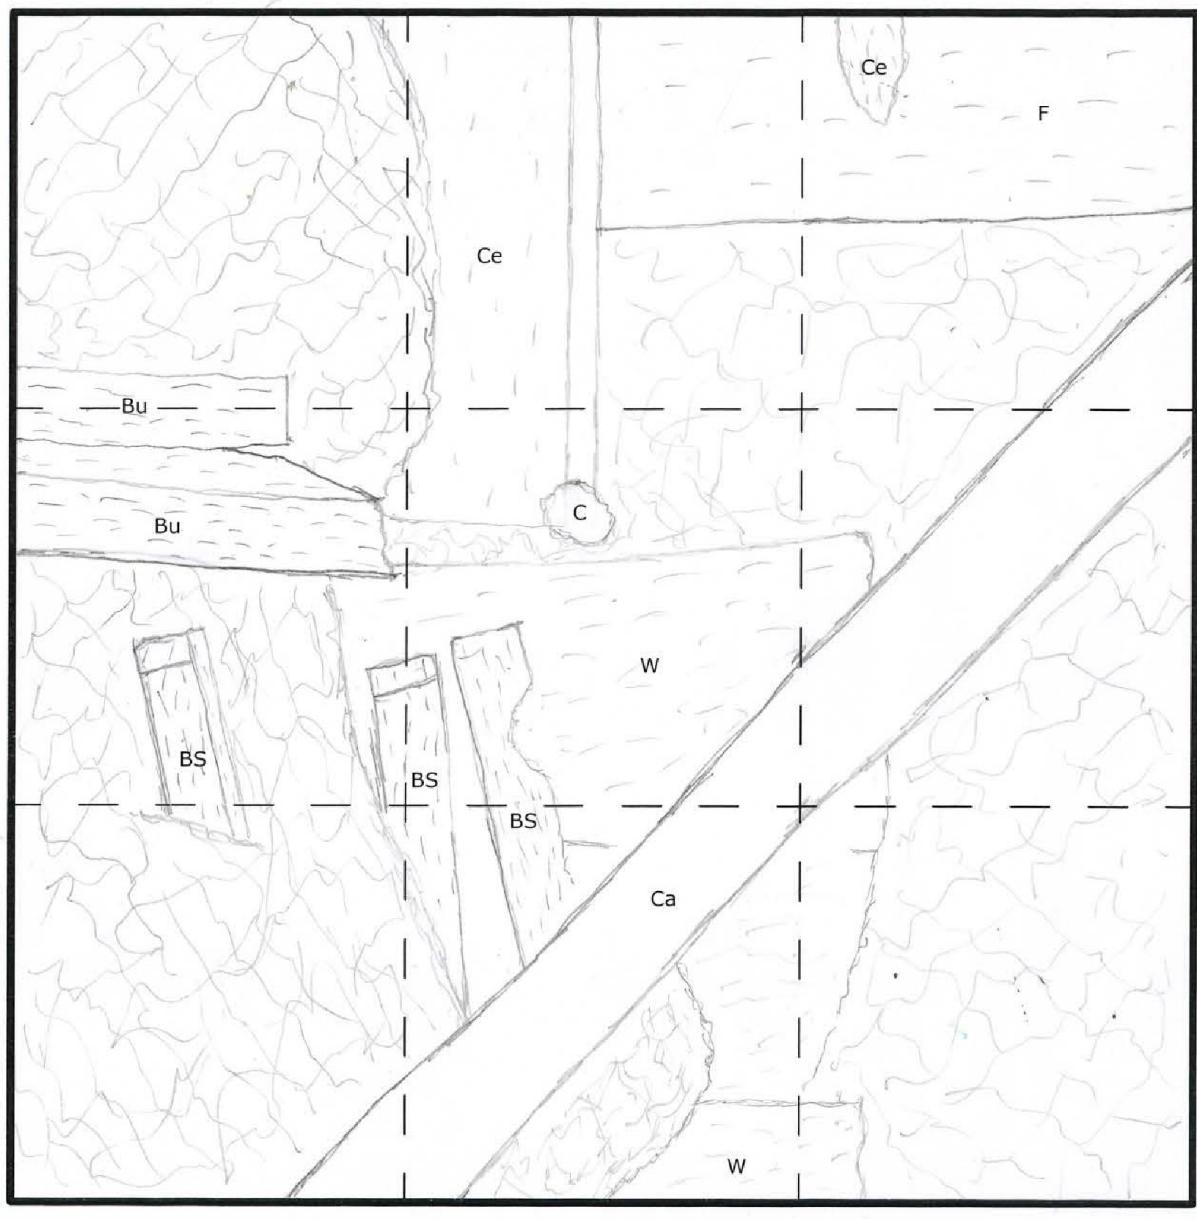
Figure 17. Pump well test pit, north section (Joshua Daniel).

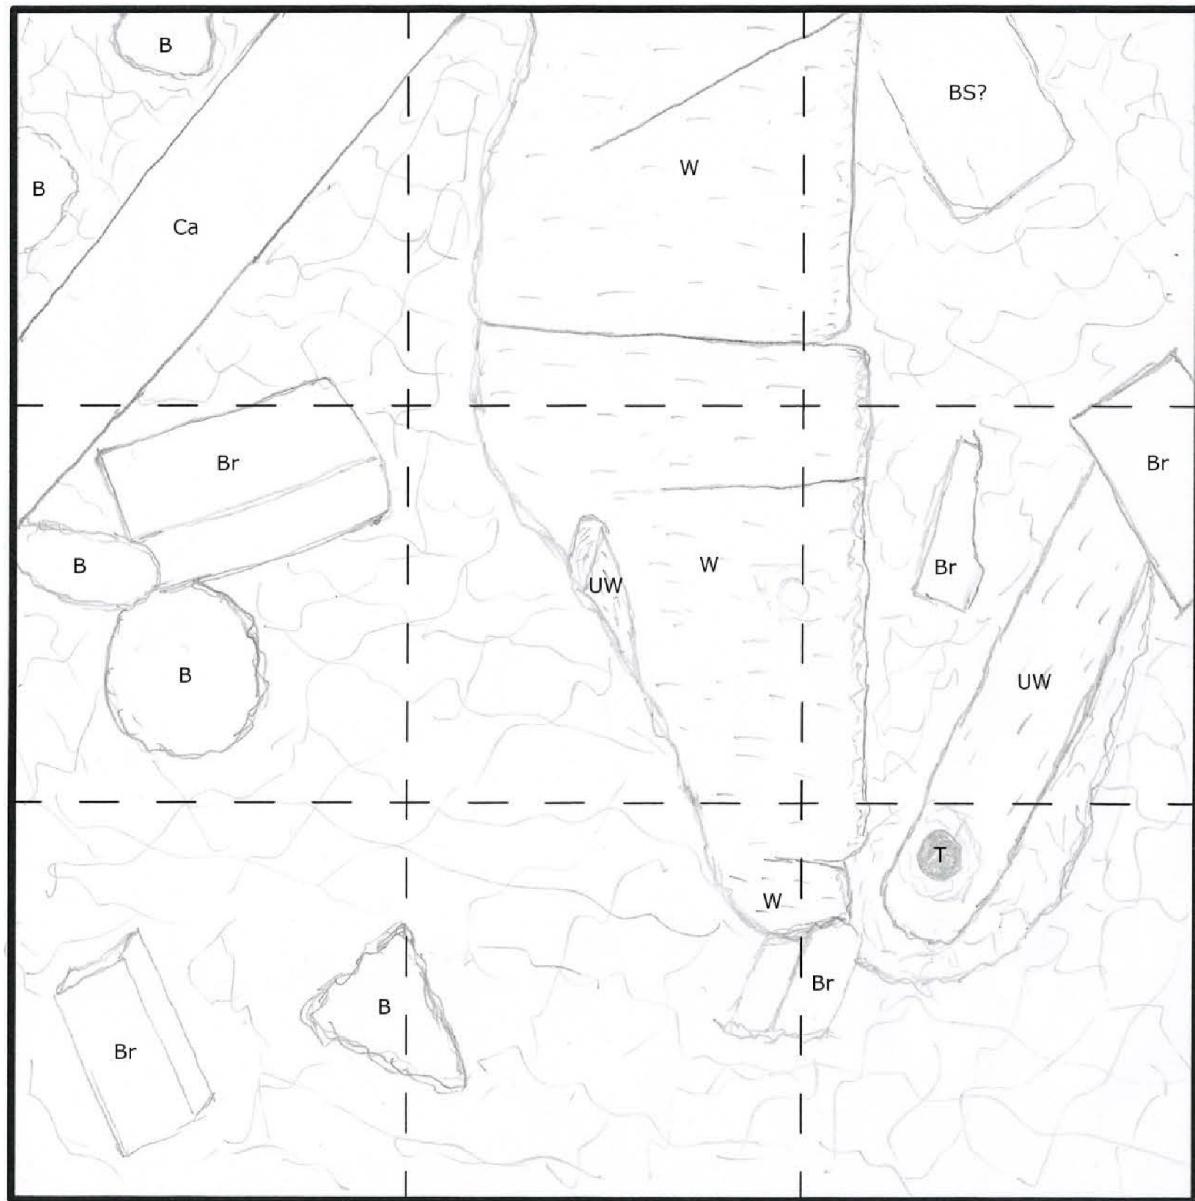
Figure 18. Pump well test pit, south section (Joshua Daniel).

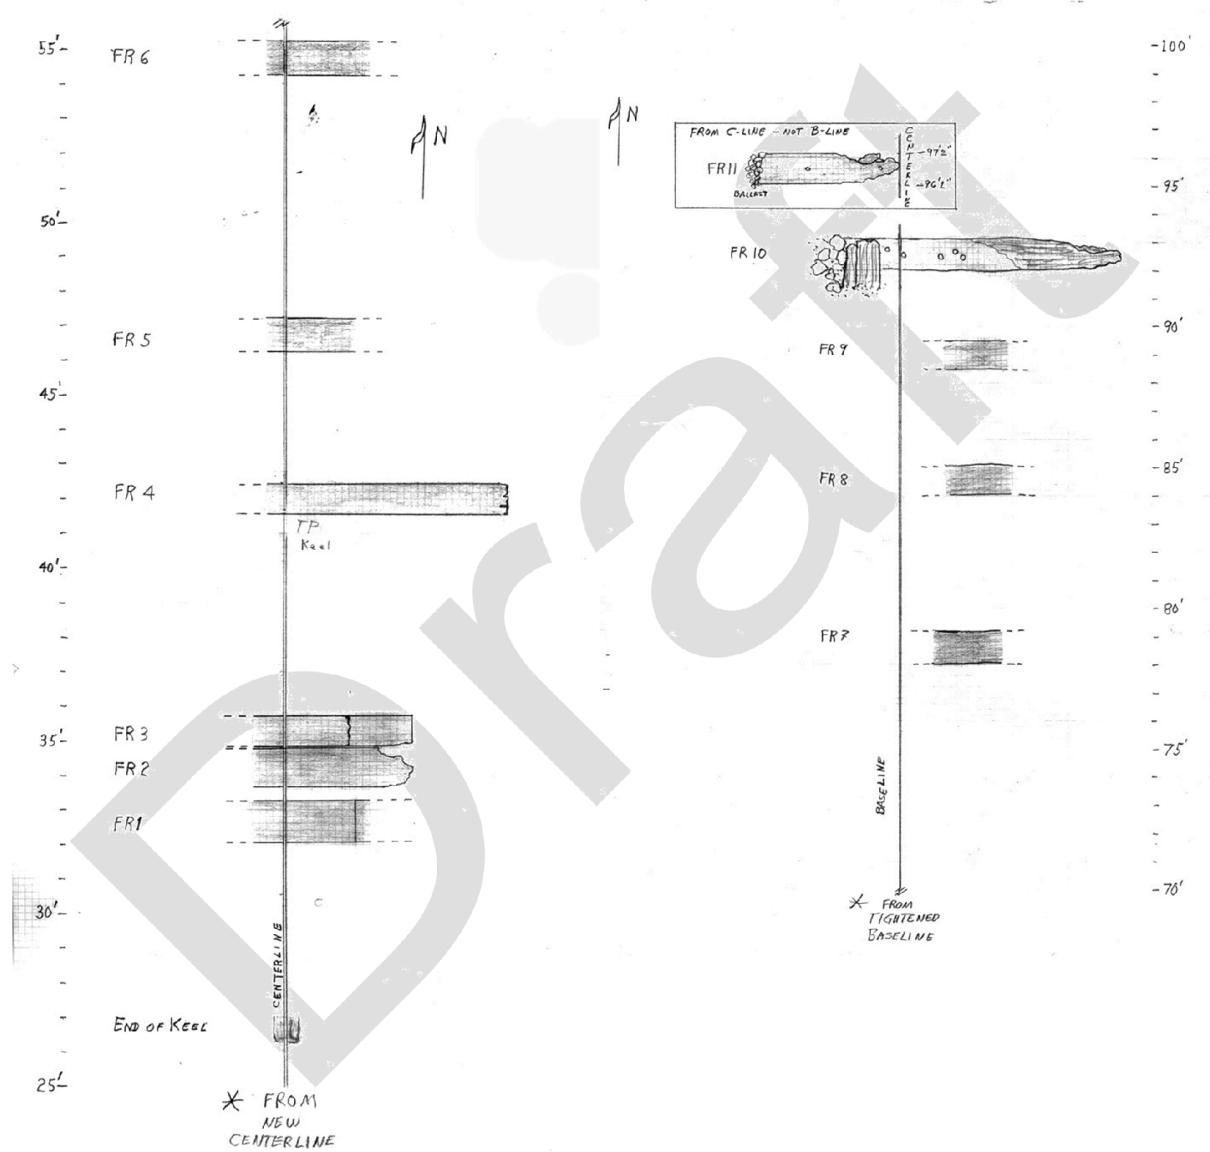
Figure 19. Locations of exposed frames, set against the new baseline (left) and the tightened original baseline (right) (John D. Broadwater).

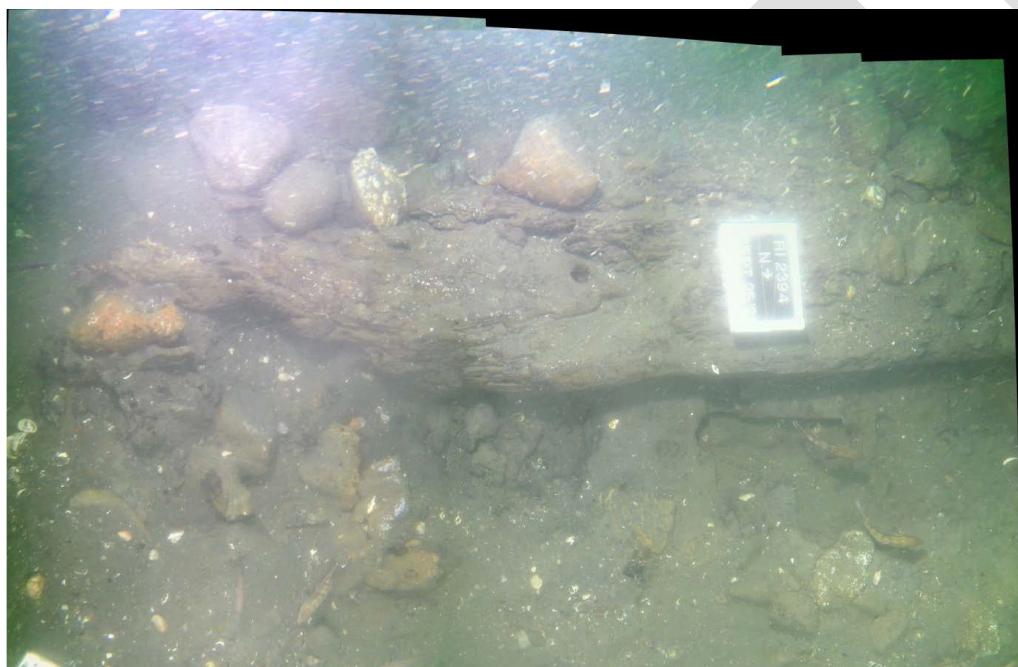
A shallow trench (Test Pit 10-North) was excavated adjacent to the northern moulded face of the frame located at 29.2 metres (96 feet) on the centreline baseline. While the objective was to locate the keel, the trench instead revealed at least six hull planks to the west of the baseline, two of which featured a scuttling hole (Figure 20, Figure 21 and Figure 22). The hole is located at the 29.56-metre (97-foot) mark on the centreline baseline and is offset 1.37 metres (4 feet 6 inches) (Figure 22).

Figure 20. Mosaic showing frame and scuttle hole beneath letter board, north to bottom (John D. Broadwater).

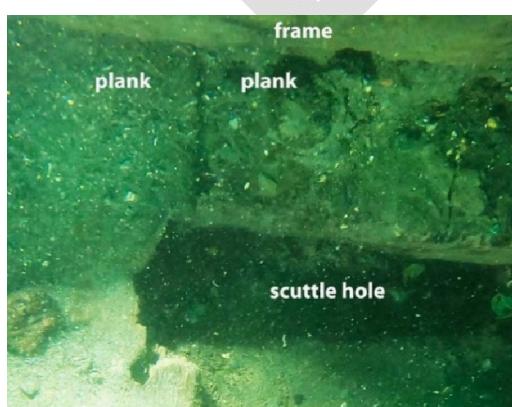
Figure 21. Close-up image of scuttle hole on the north side of the keel (John D. Broadwater).

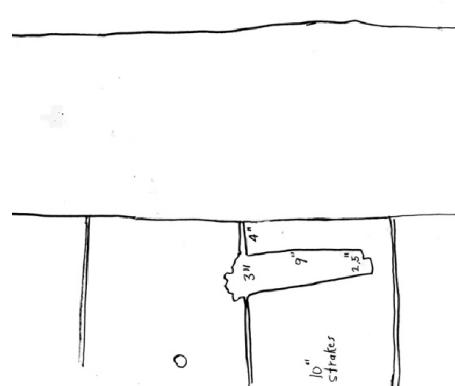
Figure 22. Sketch of scuttle hole (plan view, north to bottom)(John D. Broadwater).

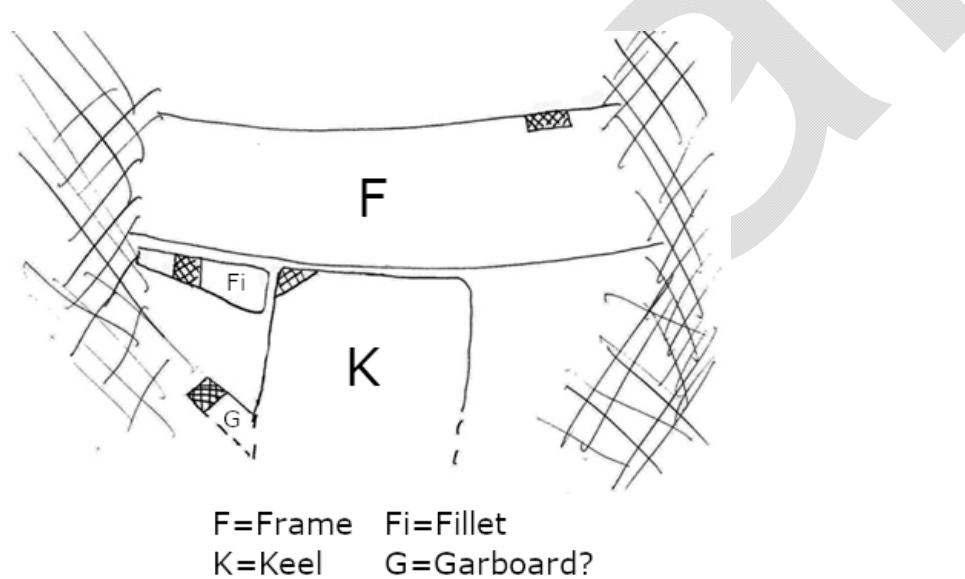
In September 2021, wood samples were recovered from four hull members in Test Pit 3-South (TP3-S): the keel, a floor timber, a fillet, and possible garboard strake (Figure 28). When a possible repair in the form of an unusual keel scarph was located in TP3-S, another sample was recovered from the keel in Test Pit 4-South in an effort to identify possible use of Indonesian timbers in repairs to the keel.

Figure 28. Locations where wood samples were recovered from TP3-S, facing north (John D. Broadwater).

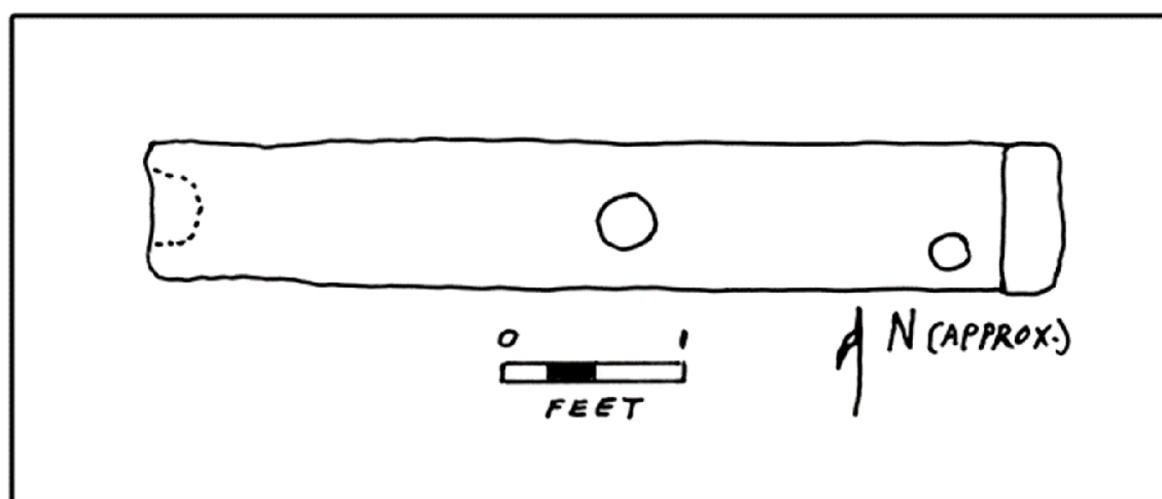
Four iron cannons are known to be present on RI 2394. During the September 2021 investigations, team members inspected the cannon located near the southern (bow) end of the site at the 9.32-metre (30 feet 5 inches) mark on the baseline. Hand fanning revealed the cannon is positioned in a predominantly flat and level orientation on the seabed beneath a thin layer of sediment. The sketch below (Figure 29) shows the cannon is lying on its side with one trunnion facing upward and the muzzle facing west (towards the wreck site's starboard side). An unidentified flat cylindrical metal object is concreted to the cannon near its breech. The muzzle opening is largely unobstructed, but the bore becomes progressively more choked with iron concretion towards the breech, and this precluded accurate measurements of its internal diameter. The cannon and surrounding sediment (which has been largely encapsulated in concretion) give the impression that something flat once rested atop the cannon and had been there for some time. Sacrificial anodes installed on frames attached to the two cannons – Cannon 1 and Cannon 2 – in RI 2394's midships section were also inspected in September 2021.

Figure 29. Sketch of the southernmost cannon (John D. Broadwater).
