AUSTRALIAN NATIONAL
MARITIME MUSEUM

Archaeological identification of the shipwreck site RI 2394 in Newport Harbor, Rhode Island, USA

Preliminary report

24 January 2022 [Amended 11 February 2022]

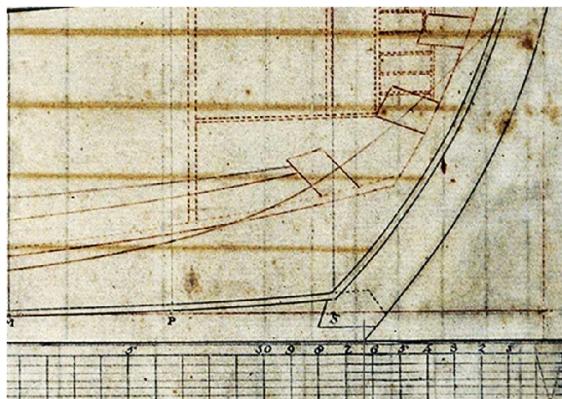
Figure 23. Detail of 1768 Admiralty draught showing Endeavour's unusual keel-stem scarph (National Maritime Museum No. 3814b, 28 March 1768).

Criterion 7 states 'additional structural features such as the location of mast steps (if extant) and the shape of the hull are consistent with those of HMB *Endeavour*'. Discovery of RI 2394's keel-stem scarph revealed it was significantly different from the 'table' and 'box' scarphs typically used in mid-to-late 18th-century British shipbuilding (see Figures 23-27). When compared with the keel-stem scarph shown in *Endeavour*'s 1768 Admiralty plan (see Figure 23), the resemblance between the two in terms of form and size are unquestionable.

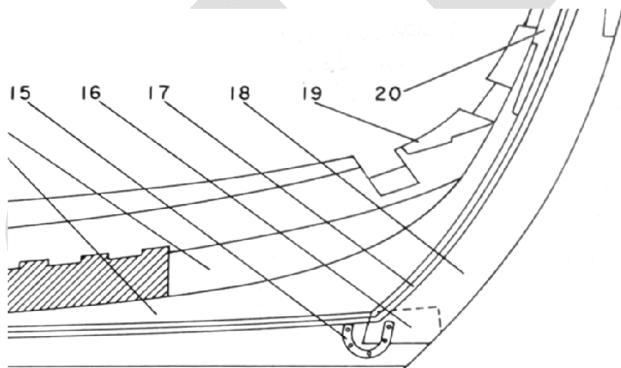
Figure 24. Detail of illustration showing Endeavour's unusual keel-stem scarph braced by a horseshoe plate (Marquardt 1995: 49).

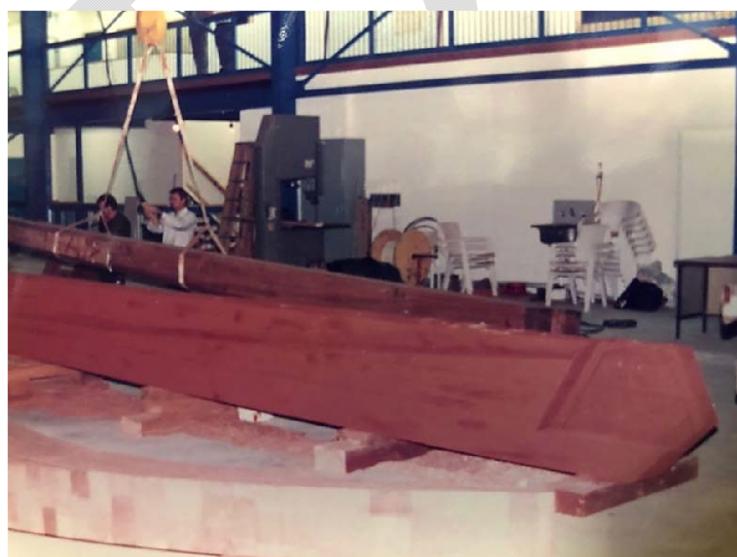
Figure 25. Keel of Endeavour replica showing the exposed keel-stem scarph (HM Bark *Endeavour* Foundation, Australian National Maritime Museum Collection).

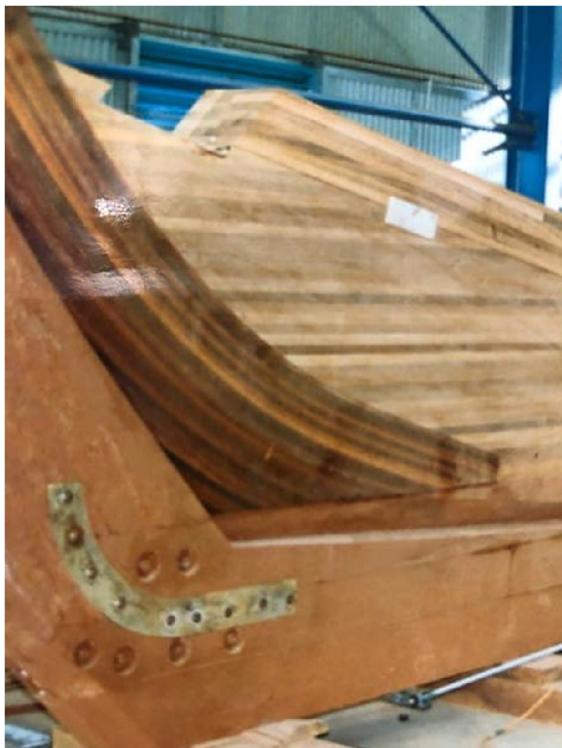
Figure 26. Endeavour replica stem and keel after being joined, showing the scarph, bolt pattern, and modified horseshoe plate (HM Bark Endeavour Foundation, Australian National Maritime Museum Collection).

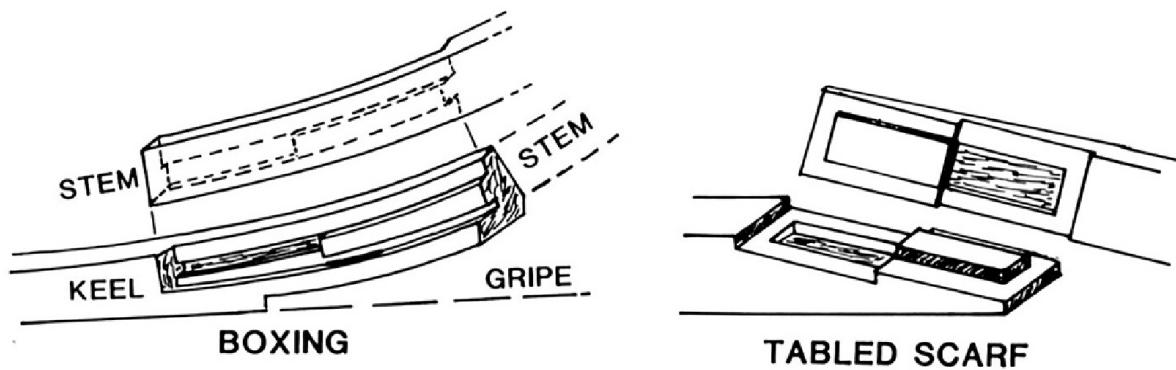
Figure 27 illustrates typical box and table scarphs used during the 18th century to join the stem and keel together. These forms of joinery are notably different from that used to join Endeavour's keel and stem.

Figure 27. Typical scarphs for joining a stem and keel together (Steffy 1994: 292).

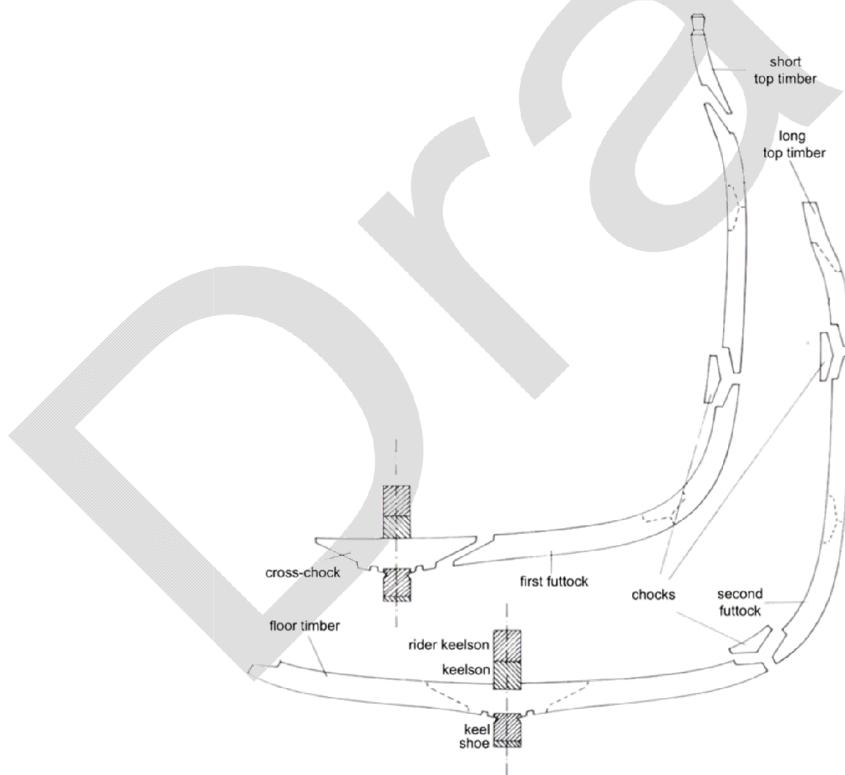
Figure 32. *Endeavour* framing schematic (Marquardt, 1995: 51).

Marquardt also illustrated what Broadwater (2020) believes is an uncommon method of constructing ship's frames. He drew frames formed from bolting a short timber (called a 'cross-chock') over the keel. The cross-chock was then scarphed to two longer timber arms that he termed floor timbers (Figure 32). The frames are drawn by Marquardt as compound

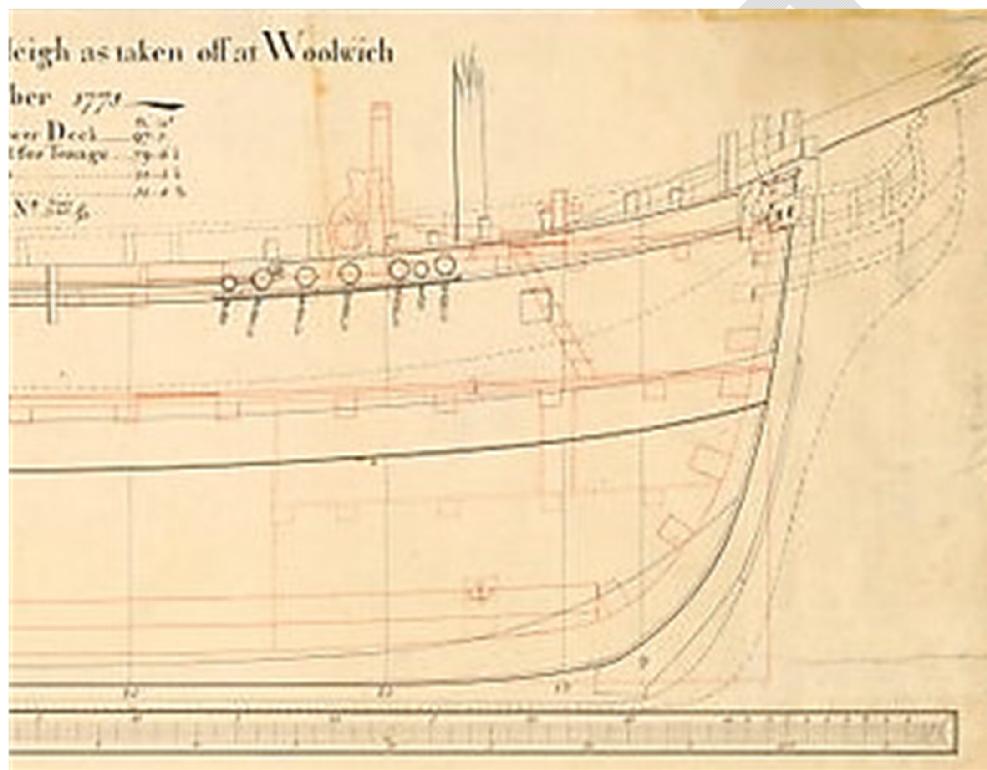
A survey of extant 18th-century ship plans held in the collections of the National Maritime Museum, Greenwich revealed draughts for 40 individual vessels, ranging from *Albion* (built 1763; NMM J2579) to *Chichester* (1785; NMM J5188). Only one of these sets of plans displayed a keel-stem scarph similar to that observed on RI 2394. That vessel, *Marquis of Rockingham* (built 1770), was another Whitby collier built by Thomas Fishburn, and was later commissioned by the Royal Navy and renamed HMS *Raleigh*. It was renamed again – this time HMS *Adventure* – and used by James Cook on his second voyage of exploration between 1772 and 1775 (Figure 33).

Figure 33. Extract from the body plans of His Majesty's Sloop Raleigh as taken off at Woolwich in November 1771. Royal Museum Greenwich 19483.
